ACB Armoring Potential Failure Modes At Dam Embankments and Spillways

Paul Schweiger, P.E.¹, Darin Shaffer, P.E.² and Jim Nadeau³

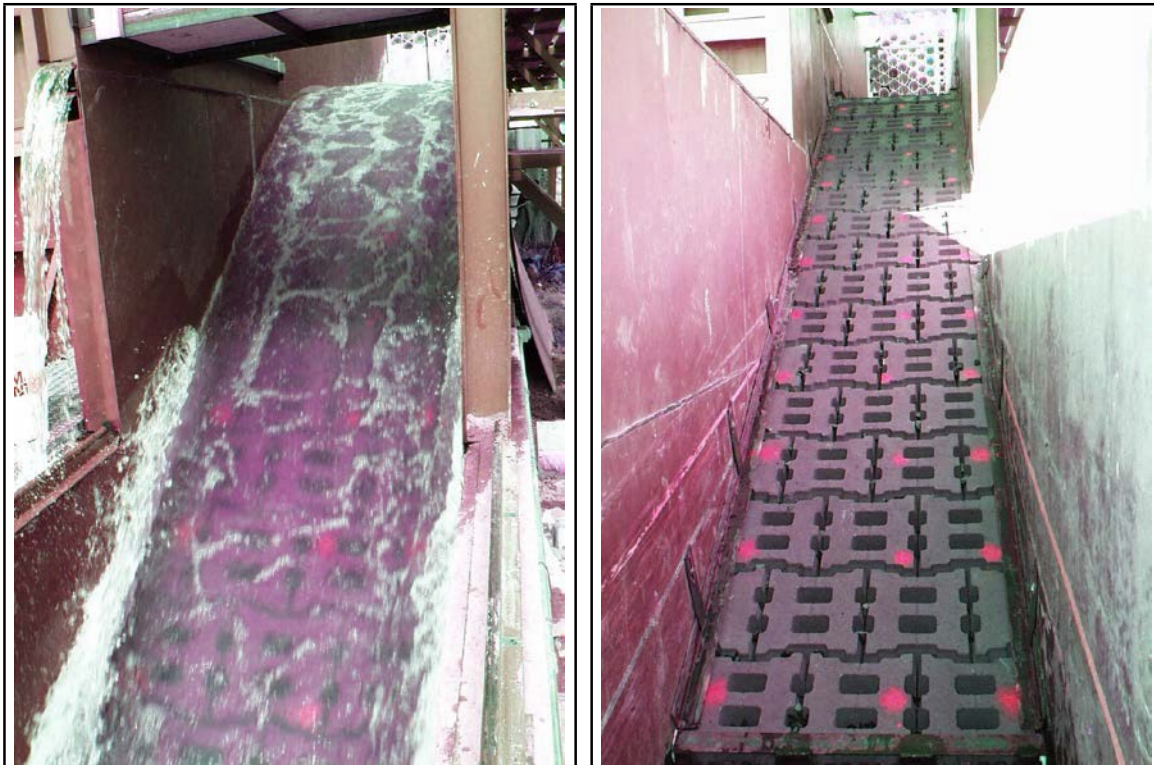
Figure 1. Full-Scale Laboratory Testing of ACB Systems at Colorado State University (Photos by Armortec)

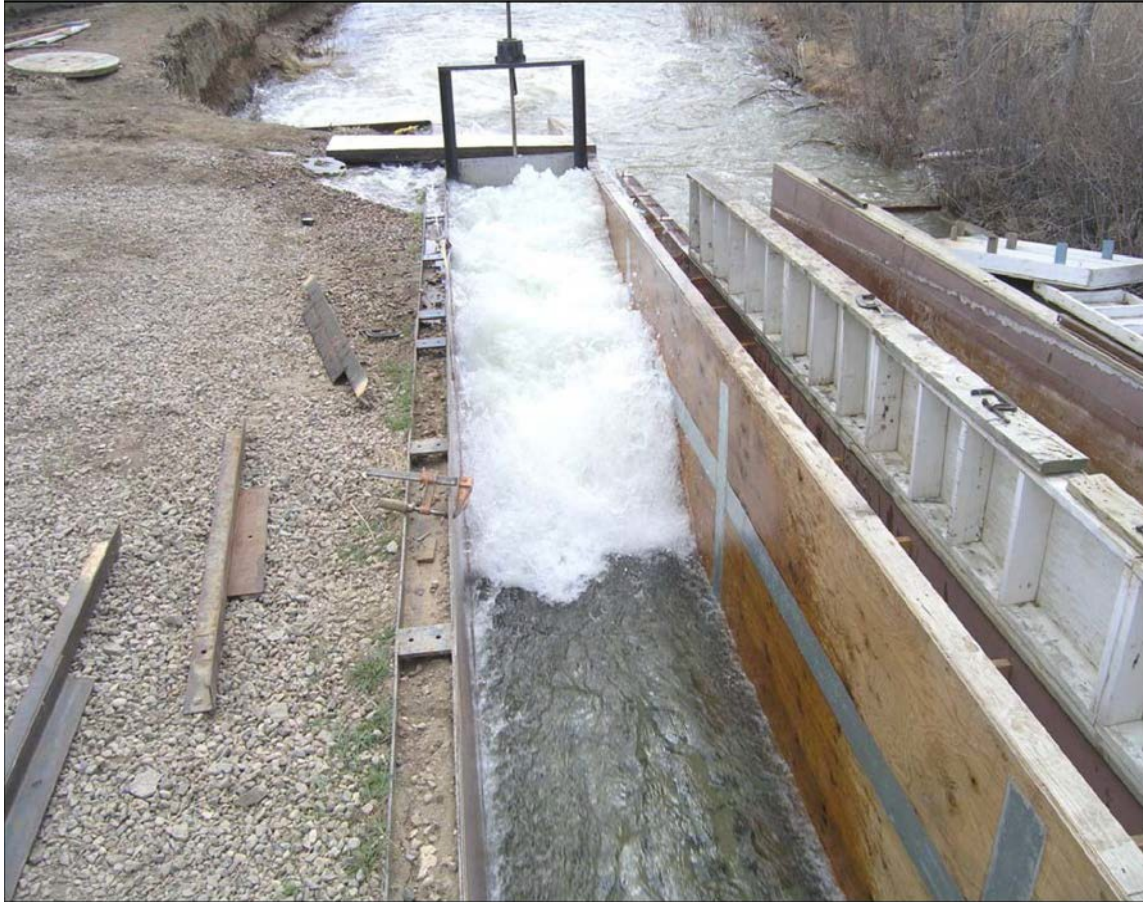
Figure 2. Full-Scale Test of Hydraulic Jump on ACBs in CSU Flume (Photo Courtesy of Chris Thornton)

In February 2011, CSU conducted hydraulic jump tests on the SD-475 OCT ACB system manufactured by Premier Concrete Products, Inc. [Pluemer et. al., 2011]. The SD-475 OCT block system is a tapered open-cell block with a maximum thickness of 4.75 inches and an average weight of 65 pounds. The tests were performed in a 4-foot-wide flume on a 70-foot-long slope with a 2H:1V slope. An 8-inch soil embankment was placed on top of the concrete flume floor. Propex Geotex 1201 non-woven geotextile fabric was placed onto the compacted subgrade embankment over which 4-inches of gravel drainage material was placed and leveled. Fortrac 30G Geogrid was placed onto the gravel drainage material before placing the SD-475 OCT blocks and chinking the open cells with gravel drainage material. The ACB system was tested in 1-foot increments of overtopping for 2-hour durations. The first test with approximately 1-foot of overtopping (15 cfs) was observed to be stable. Test 2 with approximately 2 feet of overtopping (30 cfs) yielded a transition point between stable and unstable conditions, with observed localized block instability but no loss of intimate contact. The performance threshold, as identified as loss of intimate contact with the subgrade, was reached during Test 3 corresponding to approximately 3 feet of overtopping. The aforementioned tests appeared to indicate that on flat slopes, ACBs can be stable when subjected to the influence of a hydraulic jump. As the slope becomes steeper and the unit discharge is increased, ACB systems can become unstable.

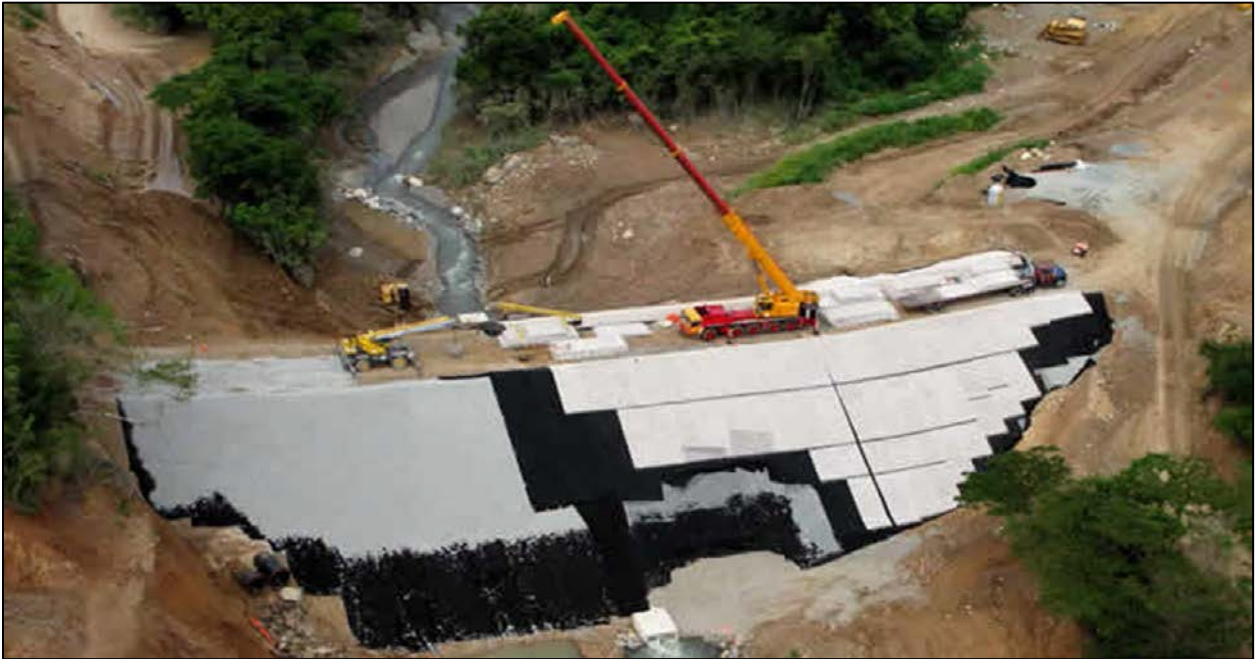
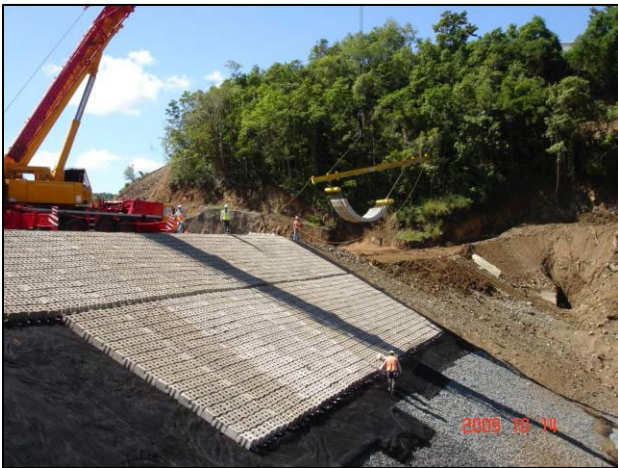
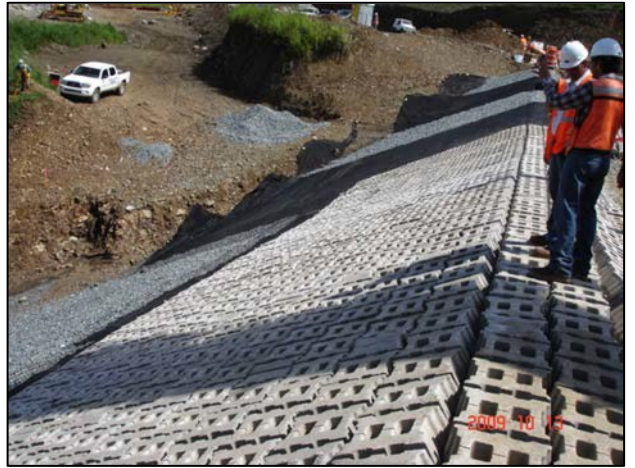
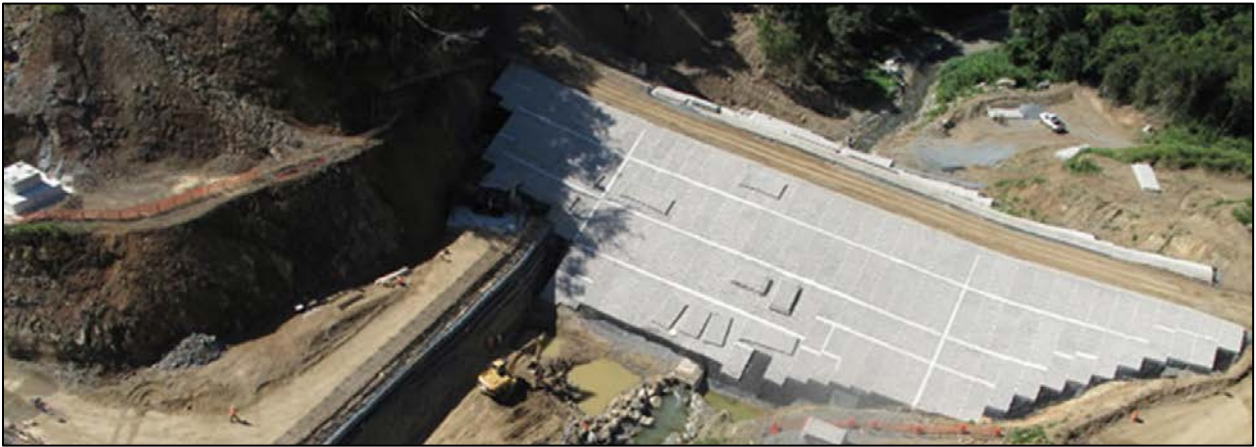
Figure 3. Photos Showing Installation of ACBs on Portugués Cofferdam, Puerto Rico (Photos Courtesy of Jacksonville District USACE)

Since the project was located in a flashy watershed, the contractor elected to construct an earthen upstream cofferdam armored with ACBs to accommodate overtopping. The cofferdam was constructed with earth fill to a height of approximately 50 feet with a 2H:1V downstream slope. The downstream slope was armored with 46,436 square feet of ARMORTEC 70T open-celled ACB mats having a maximum block thickness of 8.5 inches and an average weight of 120 pounds per block. These are the largest open-celled tapered blocks manufactured by ARMORTEC/CONTECH. The mats were cabled together with polyester rope. The foundation treatment under the ACB system consisted of placing a geotextile (CONTECH C100NW) on the earth embankment followed by 6-inches of gravel, then another layer of geotextile (CONTECH C100NW) with a geogrid (Tensar BX 1300) on top of the geotextile. The reason for placing the second layer of geotextile on top of the gravel drainage material is unknown. The sides of the ACB mats were not connected to each other and no special toe treatment appears to have been specified. A row of concrete jersey barriers lined the roadway on both the upstream and downstream sides of the top of the cofferdam. Construction photos of the cofferdam are shown in Figure 3.

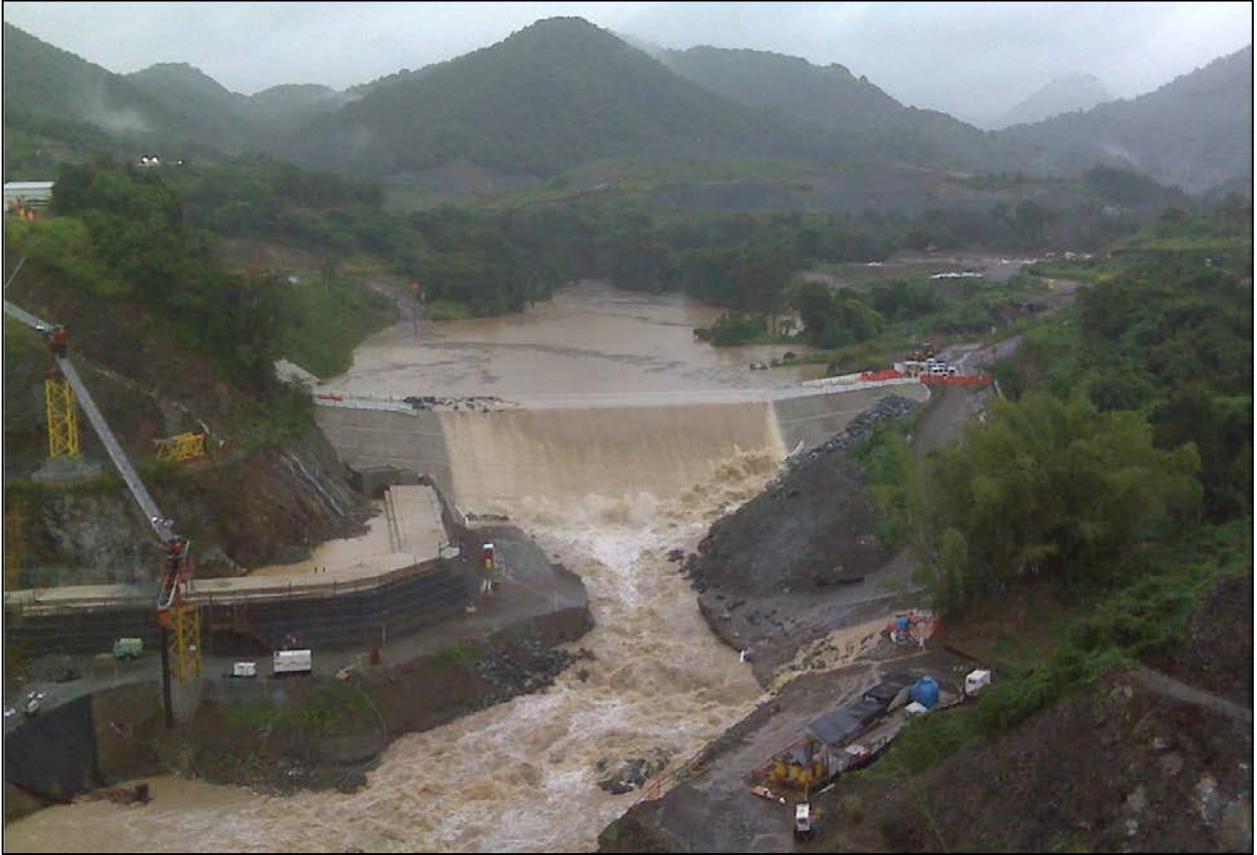
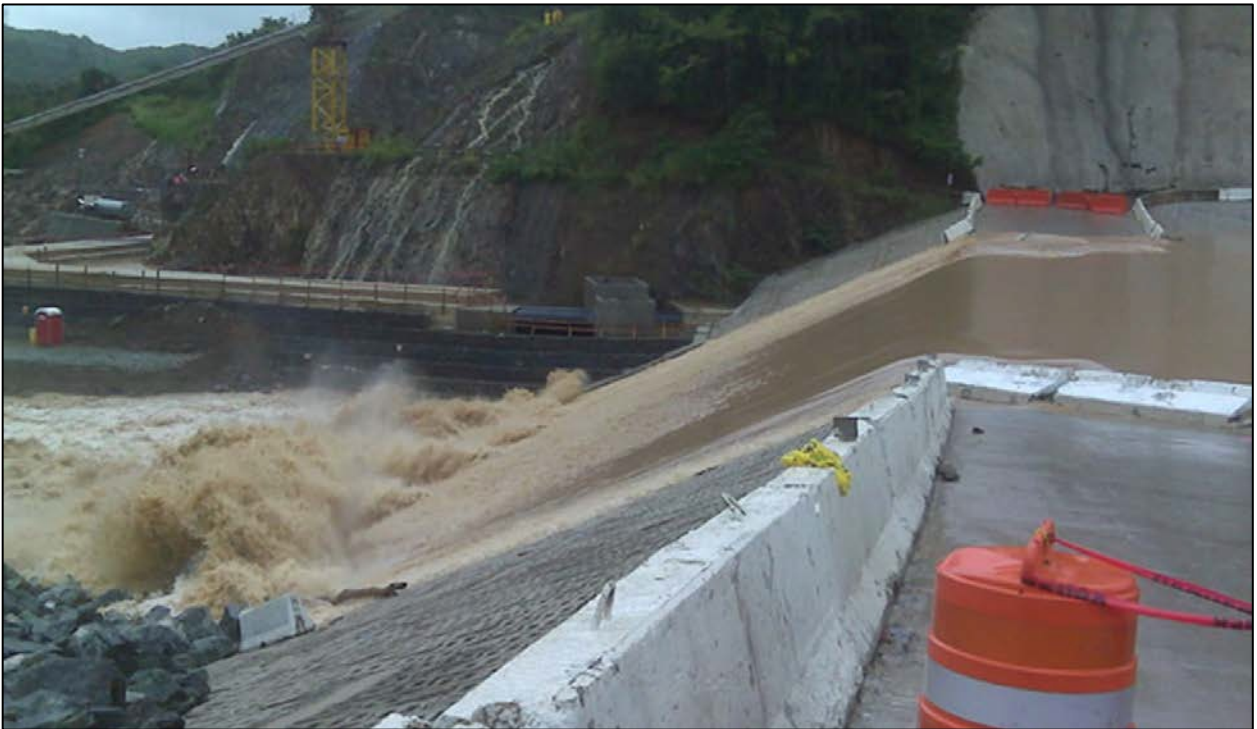
Figure 4. Photos Showing Overtopping of Portugués Cofferdam during Significant Overtopping Event (Photos Courtesy of Jacksonville District USACE)

The cofferdam was overtopped several times, with a maximum overtopping depth of approximately four feet. Photos showing the cofferdam during a significant overtopping event are provided in Figure 4. This is the most significant example of an earthen embankment armored with ACBs that was overtopped that the authors are aware of. Although the downstream toe of the ACB armoring was damaged (see Figure 5) during the most severe overtopping event, the cofferdam did not erode, and performed satisfactorily throughout construction of the RCC dam. Some of the damage to the ACBs may have occurred as a result of the concrete jersey barriers and other debris being washed off the crest of the cofferdam and tumbling down the slope.

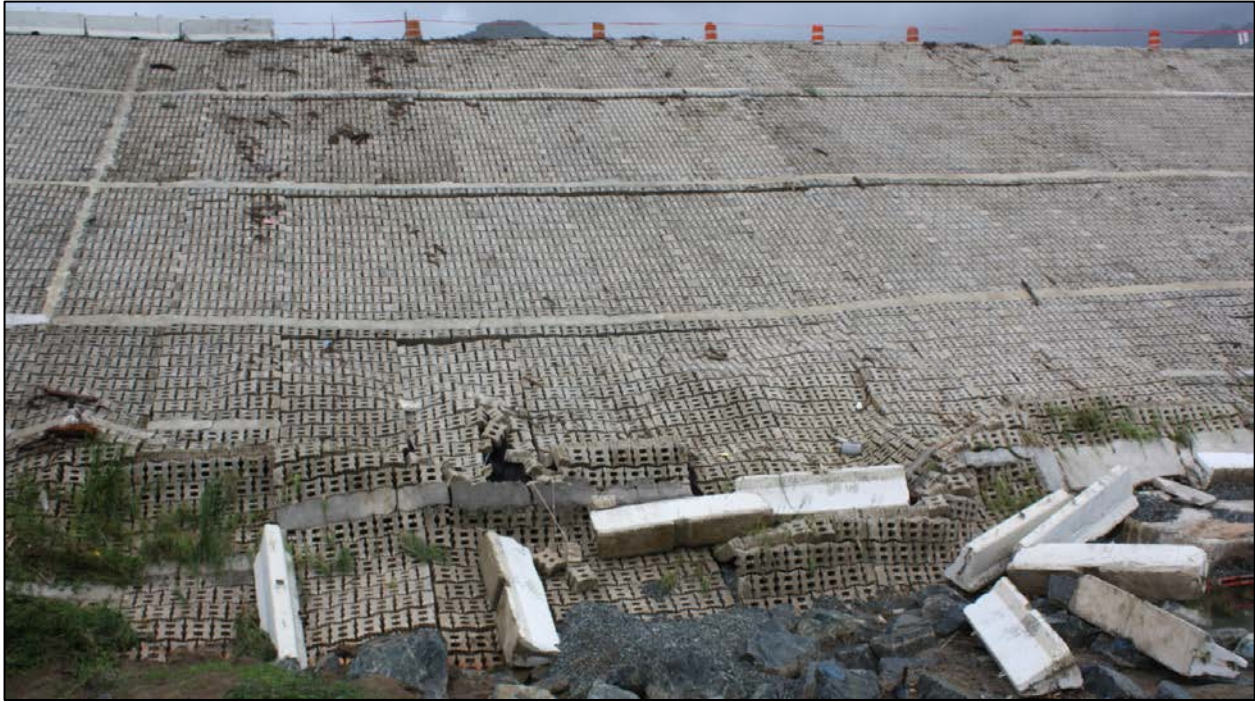
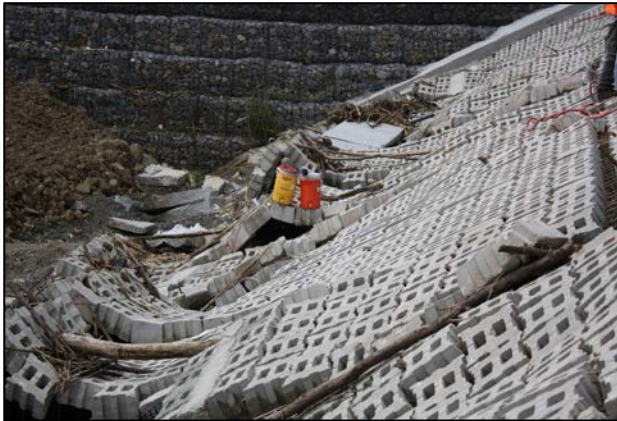
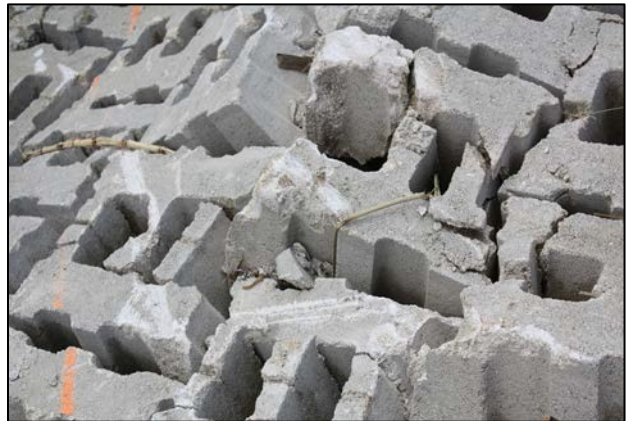
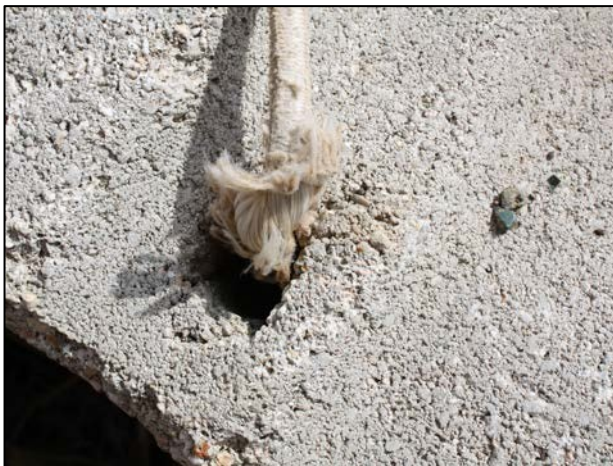
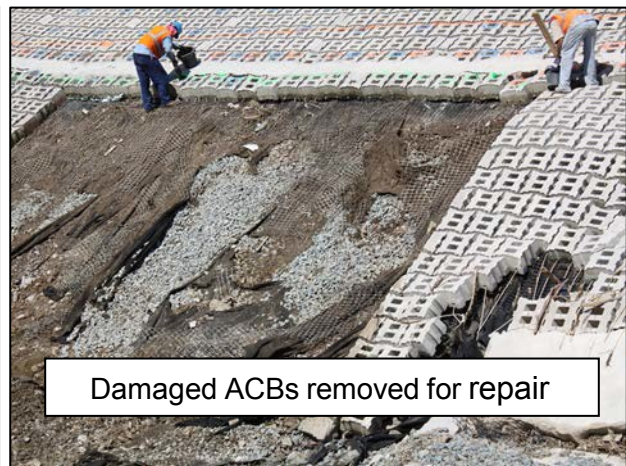
Figure 5. Photos Showing Damage to Bottom of ACB Armorment Following Overtopping of Portugués Cofferdam (Photos Courtesy of USACE)

PFM #4 – Damage to ACBs Due to Impact from Debris. Although concrete blocks can be manufactured to be highly erosion resistant and durable, they remain unreinforced and brittle. Under severe impact loads, it is possible for blocks to become damaged. At Shavers Creek Dam, during installation of the ACB system on the downstream slope of the dam, a dump truck traversing on the installed ACB armoring became unstable and flipped over onto its side. Surprisingly, the damage to the ACB system was minimal. At Portugués Cofferdam, however, during one of the more severe overtopping events, when the cofferdam was overtopped by approximately 4 feet, the jersey barriers lining both the upstream and downstream sides of the crest of the cofferdam became unstable and were washed down the ACB armored downstream slope. The 8-inch thick cast-in-place concrete cap on the crest of the cofferdam also became uplifted and dislodged, and also washed down the ACB armored slope. Following the flood event, the ACB system was inspected and some of the blocks were observed to be damaged (see Figures 5 and 10).

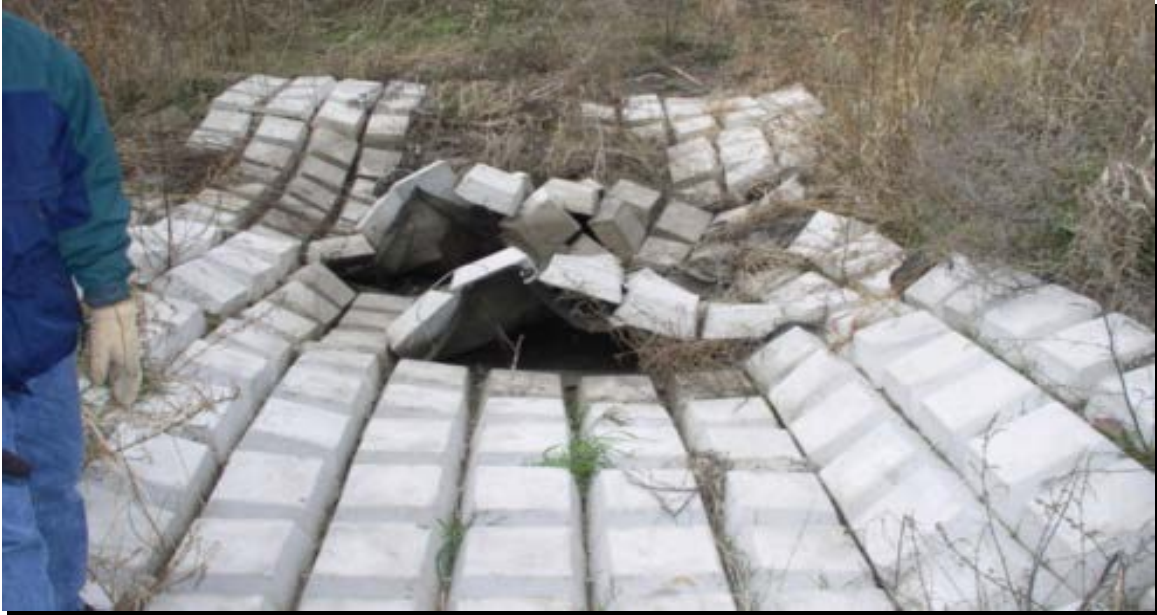
Figure 6. Photos Showing Example of PFM #1

The potential failure mode associated with placing a geotextile directly beneath the ACB mats consists of seepage flowing vertically downward through the ACB mats and geotextile both on the downstream slope of the embankment and beyond the formation of the hydraulic jump. The seepage then flows into and along the gravel drainage layer and exits upward through the geotextile and the ACB mats just upstream of the hydraulic jump where the tailwater is lowest. If the permeability of the geotextile is inadequate, or if the geotextile clogs, the geotextile will act like a geomembrane and result in uplift under the ACBs. If the uplift force exceeds the combined weight of the water and ACBs above the geotextile, the ACBs will displace upward as shown in Figure 6 and illustrated in Figure 7.

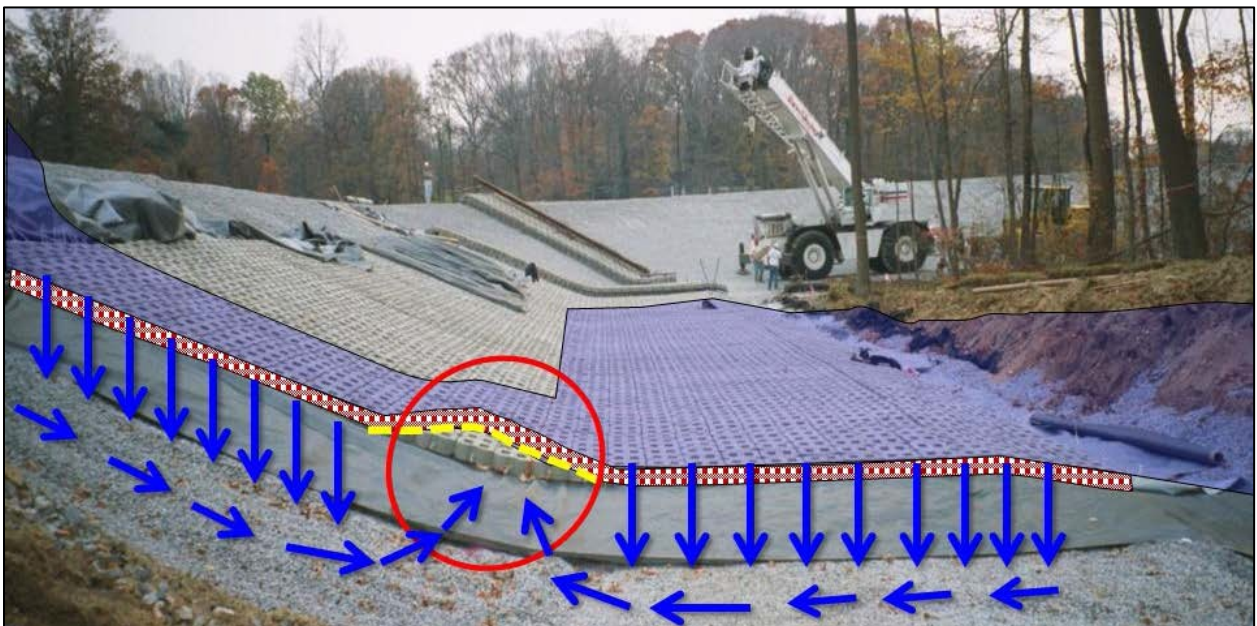
Figure 7. Schematic Illustrating Concentrated Flow from Under Geotextile to the Lowest Water Level Just Upstream of the Hydraulic Jump (PFM #1)

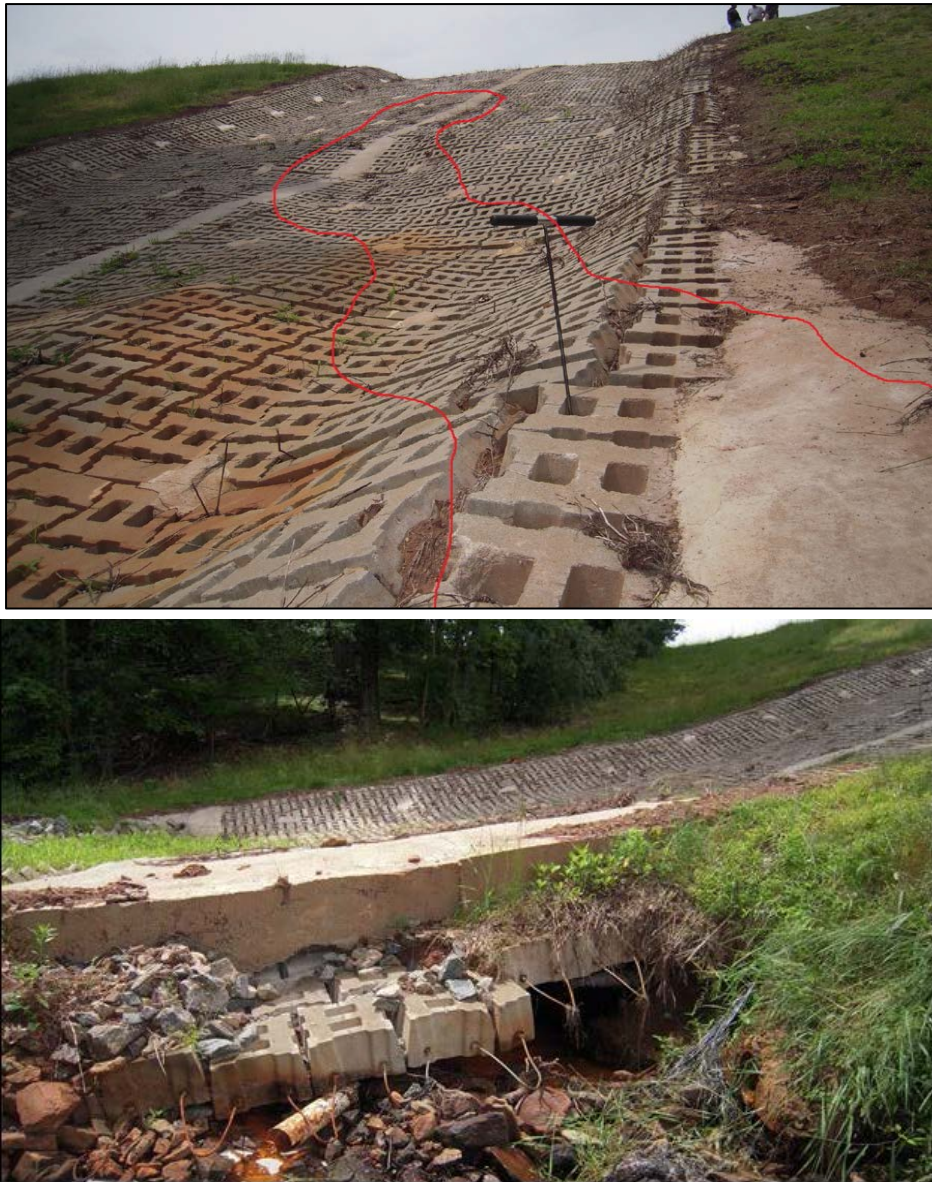
PFM #2 - Piping Under ACB Mats. Classic “piping” occurs when soil erosion begins at a seepage exit point and erodes backwards, supporting a “pipe” or “roof” along the way. Four conditions are needed for development of piping: (1) a concentrated leak/ source of water (of sufficient quantity and velocity to erode material), (2) an unprotected seepage exit point, (3) erodible material in the flow path, and (4) material capable of supporting a pipe or a roof (Von Thun 1996). In the ACB embankment armoring example shown in Figure 8, the ACB-lined channel on the embankment is perched at the toe of the dam creating a hydraulic gradient from the flow in the spillway chute to a low point beyond the left side of the ACB armored chute. The hydraulic gradient must be sufficient to cause seepage and erosion at the exit point. If the seepage exit is unfiltered, the earth material along the flow path can erode. Erosion or piping is then initiated and can continue from the unfiltered outlet and progress upstream under the ACB armored layer towards the crest of the embankment. In the photo in the top of Figure 8, the piping erosion terminated near the crest of the dam because the flow over the spillway stopped. Had the flow over the ACB armoring persisted, the piping would have progressed through the crest of the dam embankment and ultimately breached the dam.

Figure 8. Photographs Showing Piping Under the ACB Armoring Over an Embankment (Top) and the Piping Outlet (Bottom).

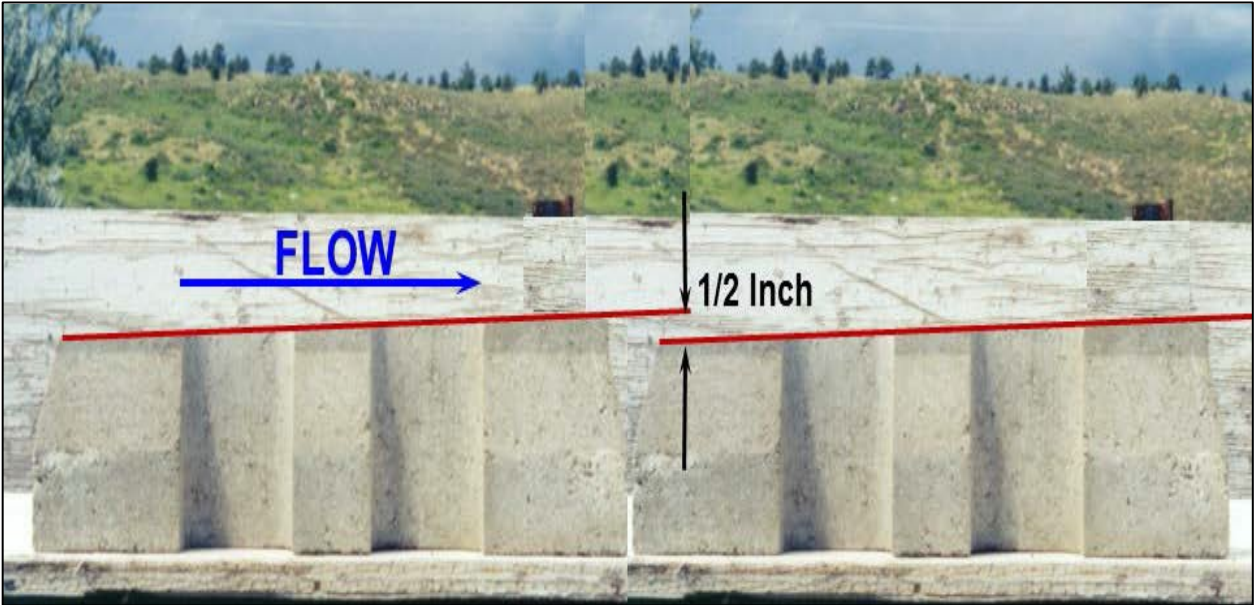
PFM #3 – Installation Errors of ACB Armoring. For steep-sloped, high-velocity applications, the additional destabilizing force associated with form drag, where the frontal profile of the block is subject to direct impact by the flow often controls the selection of the ACB system. A vertical projection of 0.5 inches is often assumed for typical project conditions (Armortec, 2000). The tapered ACB system consists of a downstream thickness of approximately 0.5 inch greater than the upstream. The taper is designed to eliminate/minimize the effects of the vertical projection (see Figure 9).

Figure 9. Photograph Illustrating Tapered Block System.

The authors have observed ACB mats being installed backwards with the tapered blocks facing the wrong direction. This mistake can occur if the contractor is not aware that the blocks are tapered, since the taper can be subtle and the ACB mattresses are symmetrical. If the ACB blocks are installed backwards, the blocks will have a protruding upstream face that will result in significantly increased form drag that can destabilize the system.

A recommended requirement is to have the ACB manufacturer's technical representative onsite during installation of the ACB system to ensure that the ACBs are installed correctly. Some ACB systems have arrows stamped onto the blocks, or paint on the downstream edge of the block to help contractors install the ACB mats correctly.

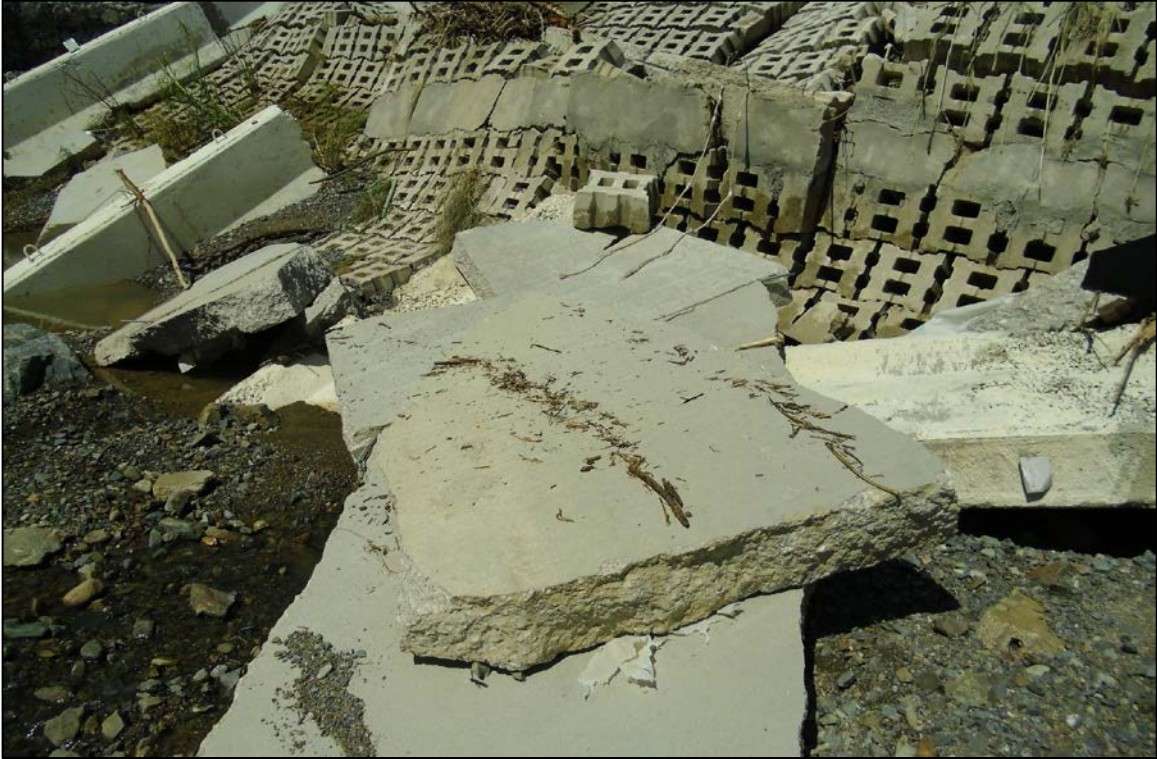
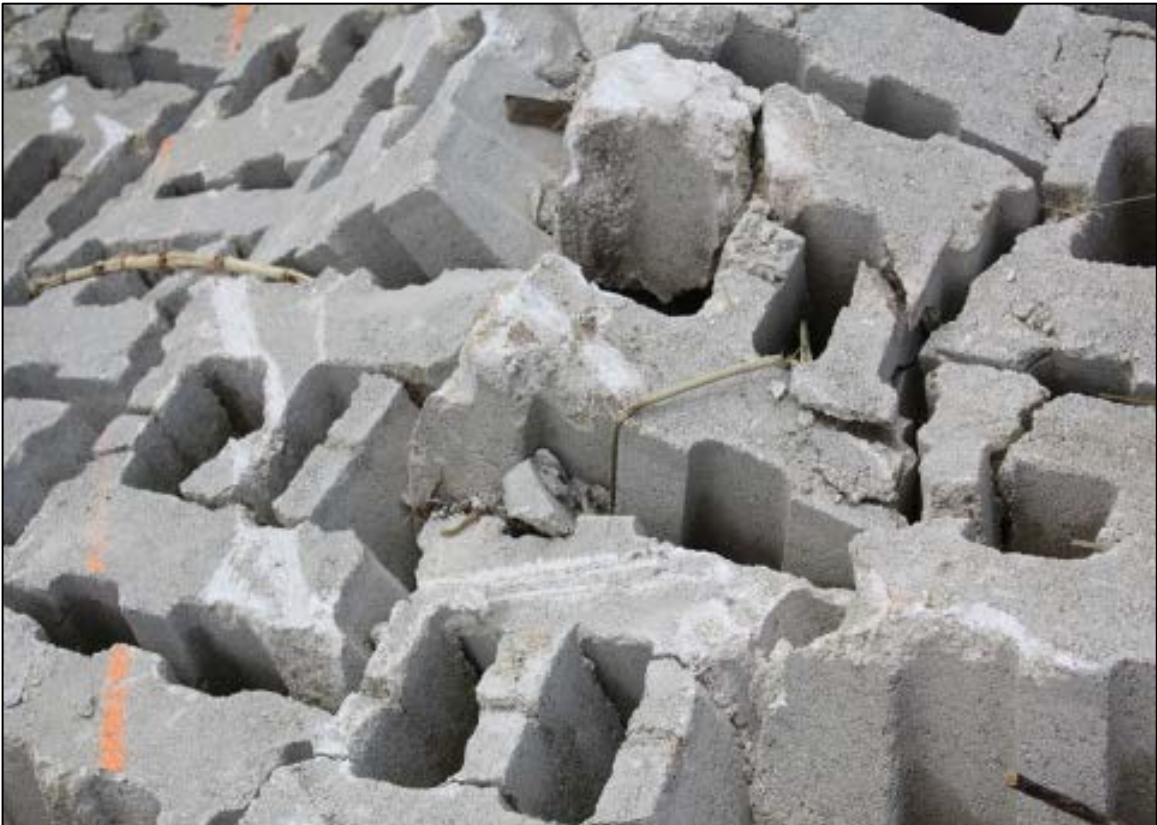
Figure 10. ACB Armoring on Portugués Cofferdam Damaged from Debris Impact (Concrete Jersey Barriers and Concrete Slabs).

Despite the damage to the ACBs, the system remained intact and continued to provide erosion protection. Following the overtopping event that caused damage to the ACB armoring, the contractor repaired the damage and replaced the concrete jersey barriers with plastic jersey barriers (see Figure 11).

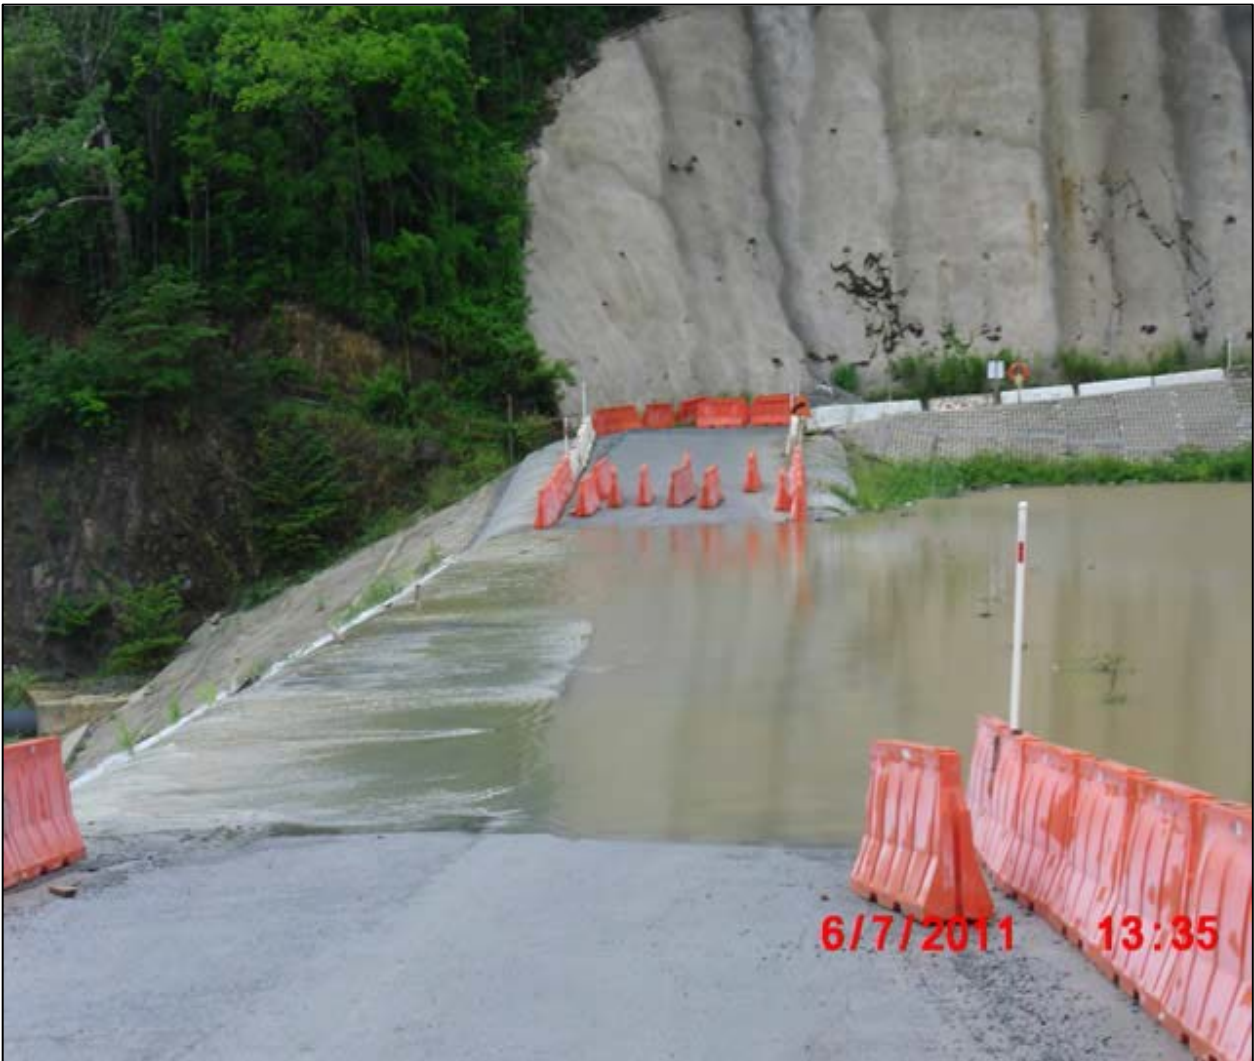
Figure 11. Photograph showing plastic jersey barriers used to replace the concrete jersey barriers at Portugués Dam to prevent impact damage to the downstream ACB armoring should the jersey barriers become unstable and wash down the downstream face of the ACB armored cofferdam.

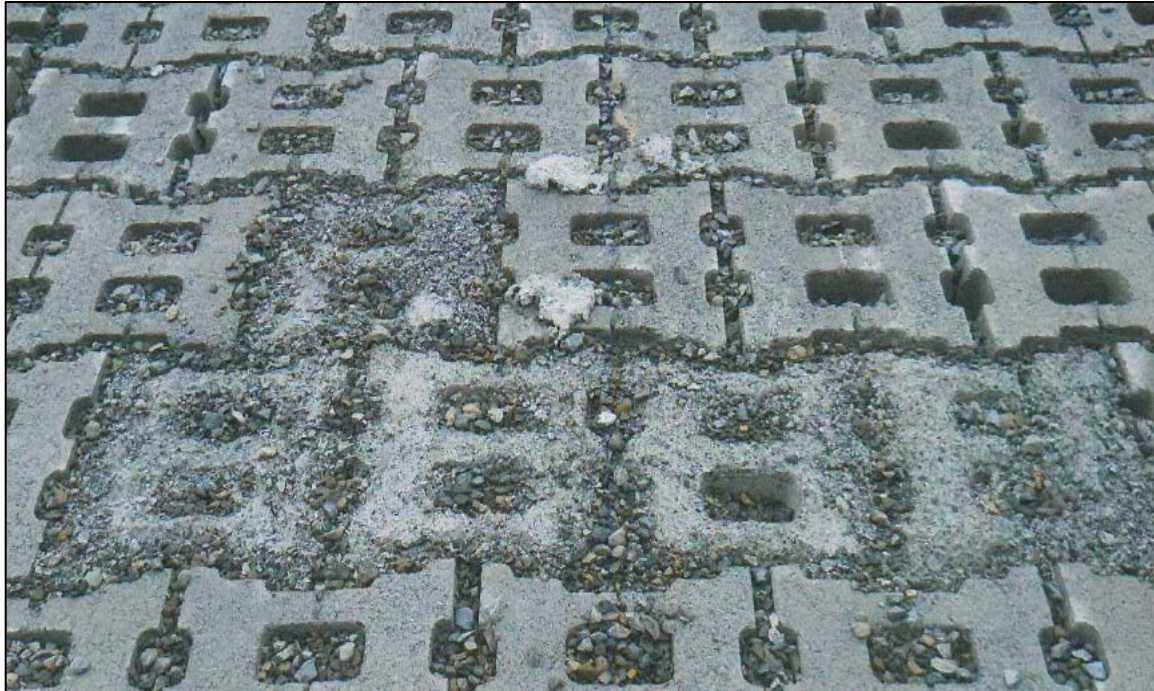
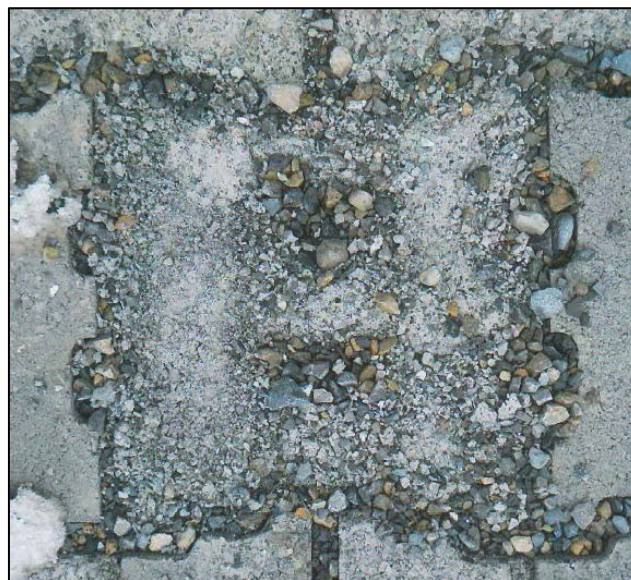
The authors are aware of one ACB installation at Lake Mokoma Dam in Sullivan County, Pennsylvania where the installed ACB system experienced premature deterioration and disintegration of some of the concrete blocks (see photos in Figure 12). Initially it was believed that the problem was related to insufficient compaction and “popcorning”, a phenomenon in the dry cast concrete process that sometimes occurs at the end of a manufacturing cycle/batch with dry cast material. These blocks are normally culled at the point before the concrete blocks are moved onto racks and into the kiln. After curing is the last opportunity to discard the blocks before the blocks are incorporated into mats. Regardless of the exact reason why the blocks were of poor quality, the problem was related to the manufacturing of the blocks and poor quality control at the plant. This appears to have been an isolated incident, however, it reinforces the importance of specifying random testing of the ACB blocks being installed along with other quality control measures.

Figure 12. Photographs of Deteriorated ACB Blocks Due to Poor Quality Control during Manufacturing

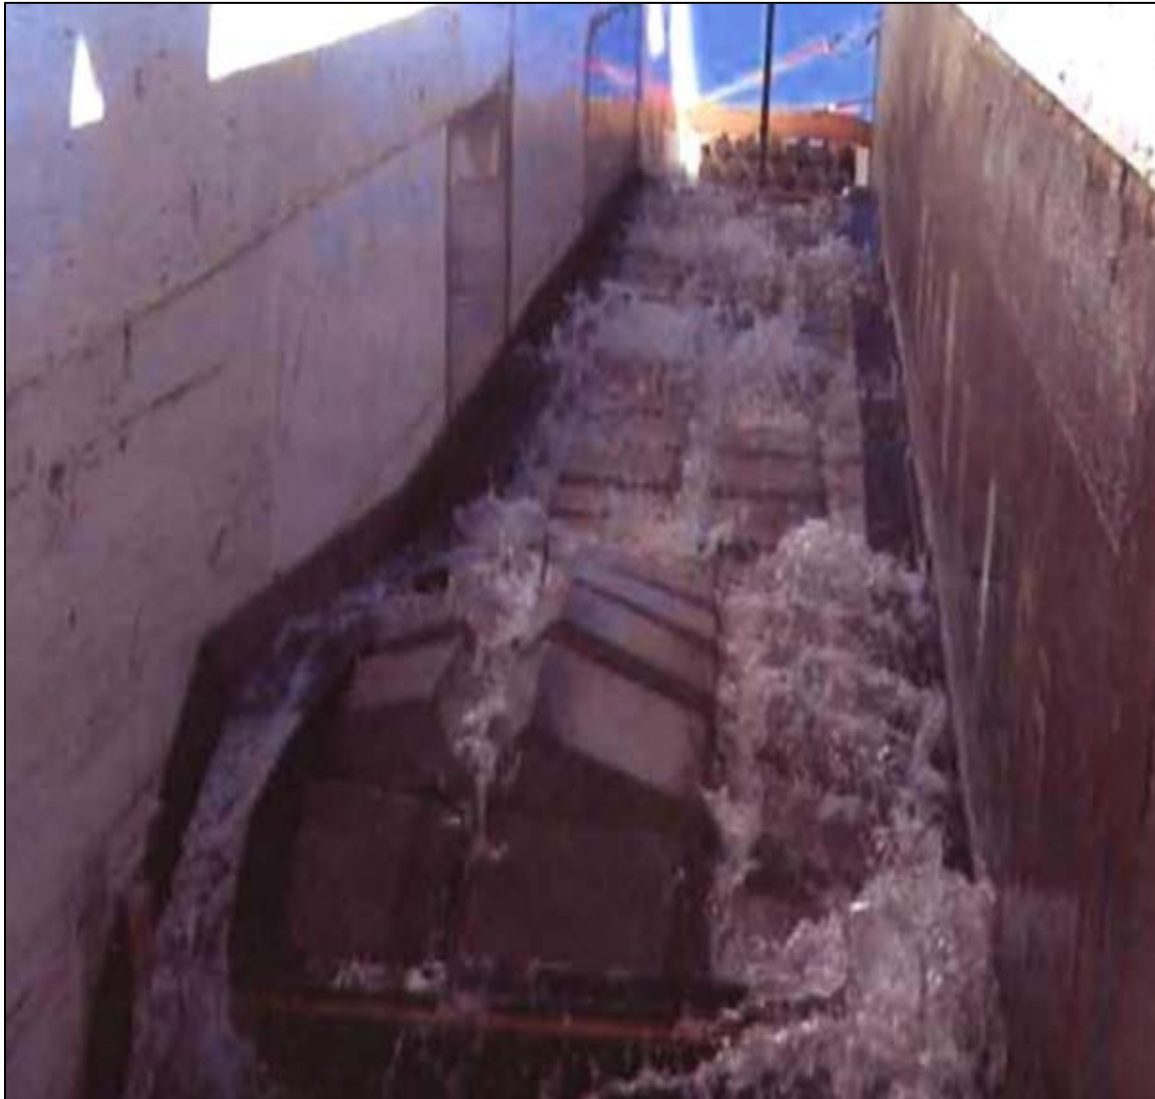
PFM #6 – Use of Unproven ACB Systems and Installation Details. Full-scale flume tests on a closed-cell ACB system was performed at the CSU testing facility in 2004. It was determined that the revetment system reached performance thresholds after only 8 minutes of overtopping flow (~1-foot of overtopping) due to buckling of the blocks near the toe plate. The testing was stopped upon observing the buckling of the blocks. The highest lift of individual blocks was approximately 0.5 feet at the peak of the deformation (see Figure 13). This full-scale testing demonstrates that there are differences between ACB systems and their under treatment that can make a significant difference in their performance and stability. Therefore it is very important that only ACB systems with satisfactory laboratory or other performance data be used.

Figure 13. Photograph Showing Laboratory Testing of an ACB System that Failed after 8 Minutes of Testing Under 1-foot of Overtopping (Photo looking upstream).

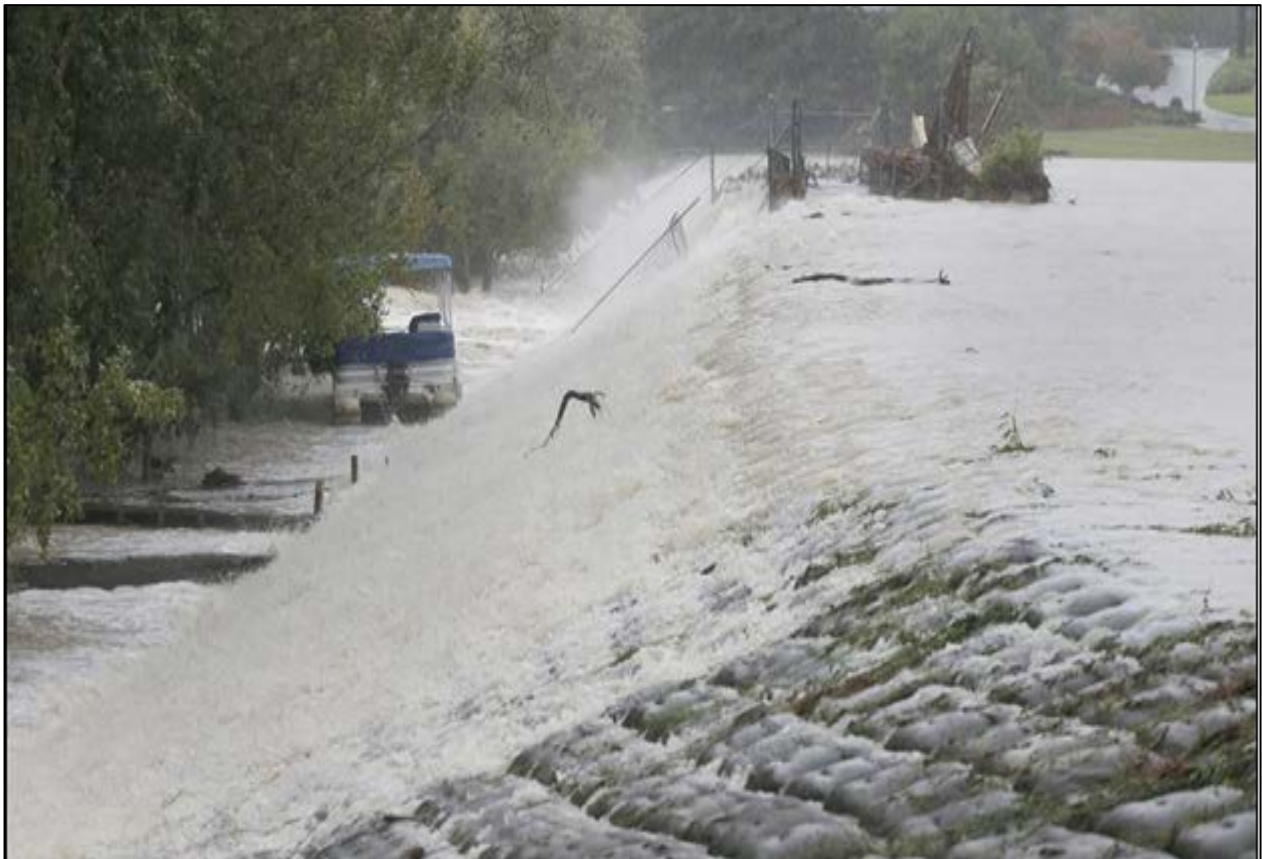
PFM #7 – Deterioration from Exposure. If the ACB system is exposed, it may be subject to deterioration from normal weathering and erosion. Forest Lake Dam is an embankment dam in Columbia, South Carolina that was armored with a Fabriform ACB system in the 1980s. The Fabriform Articulated Block revetment system consists of rectangular concrete blocks cast in place within a nylon fabric or quilt, and linked together by reinforcing cables (if required) inserted between the two layers of fabric prior to fine aggregate concrete injection. Forest Lake Dam was overtopped in 2015 and successfully protected the embankment from erosion (see Figure 14). Similar embankment dams located upstream and downstream that were not armored failed or were significantly damaged as a result of overtopping.

Figure 14. Photograph of Forest Lake Dam Showing Overtopping of Embankment Dam Armored Using Fabriform ACB System during Hurricane Joaquin
