ACB Armoring Potential Failure Modes At Dam Embankments and Spillways

Paul Schweiger, P.E.¹, Darin Shaffer, P.E.² and Jim Nadeau³

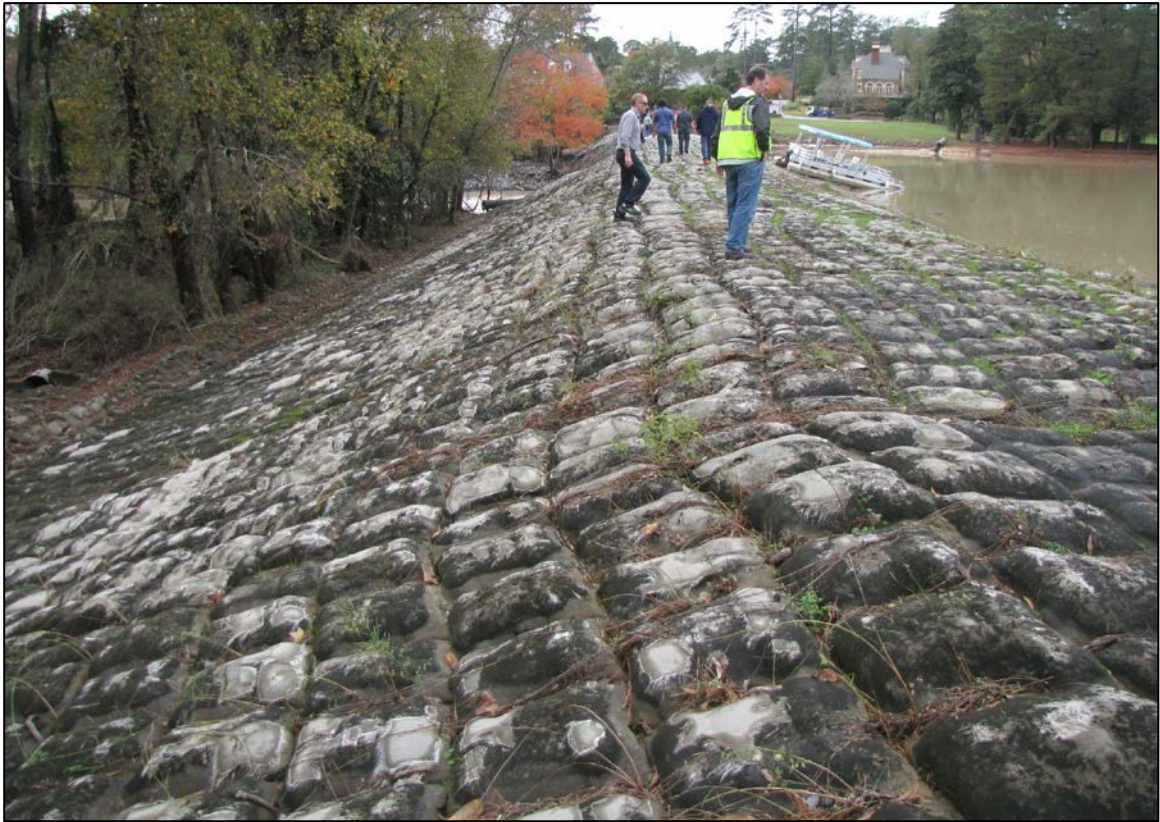
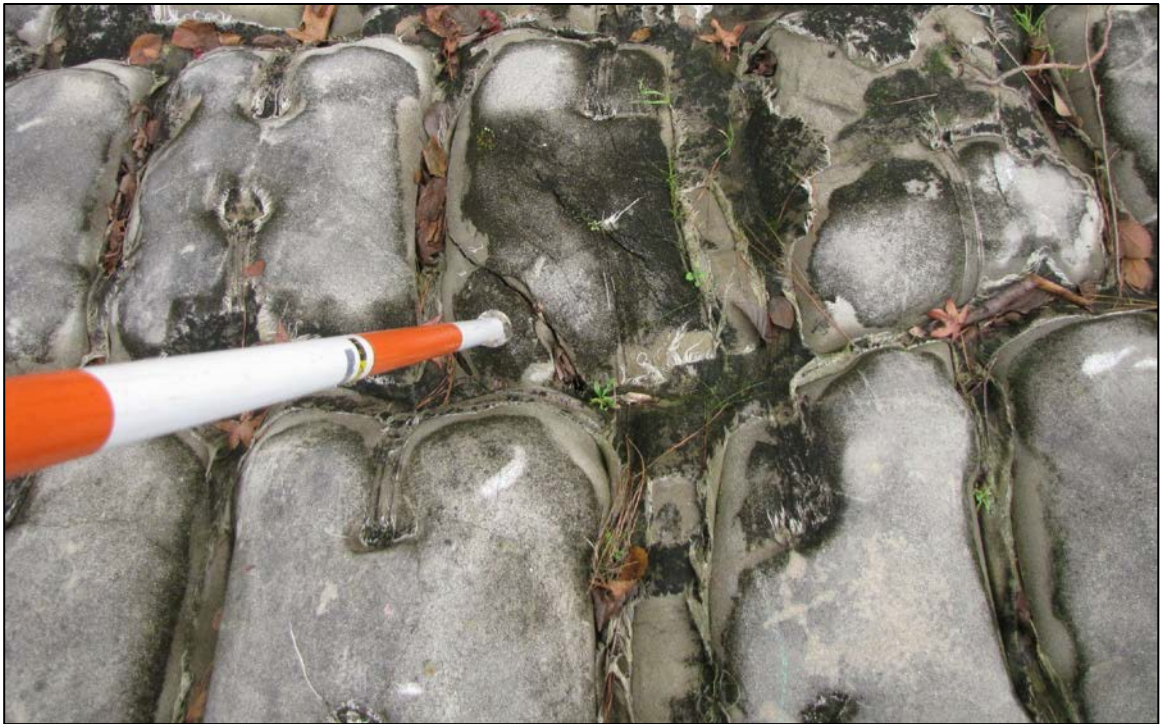
Inspection of the Fabriform ACB system at Forest Lake Dam after the 2015 overtopping event showed that the system remained intact. The nylon material that holds the concrete blocks together, however, was showing significant signs of deterioration (see photographs in Figures 14 and 15). The deterioration consists of missing nylon fabric over the tops of many of the concrete blocks. Some of the exposed remaining nylon fabric was weak and easily removed by hand. The nylon fabric that was not exposed (around the edges and underneath the concrete blocks) appeared to remain strong and durable. As the exposed nylon fabric continues to deteriorate, the concrete blocks will eventually lose the benefits of this restraint (unless the system included the optional internal cables) and lose their full capacity to protect the embankment from overtopping flows. At some point, the condition of this ACB system will need to be assessed and potentially reinforced or replaced to continue providing the needed protection for the embankment.

Figure 15. Photographs Taken in 2015 Following a Overtopping of Forest Lake Dam during Hurricane Joaquin Showing Condition of Fabriform ACB System Installed in the 1980s

For most ACB systems, deterioration of the concrete blocks can be addressed by specifying a suitable mix design that is appropriate for the exposure conditions. For example, a mix design with a higher compressive strength may be specified for exposure conditions subject to frequent freeze-thaw cycles or aggressive soil or water conditions such as salt water or acidic soils. Oversized nylon or stainless steel cables can also be specified for greater durability. Completely covering the ACB armoring with topsoil and seeding is another option to protect the ACB system from deterioration due to exposure.

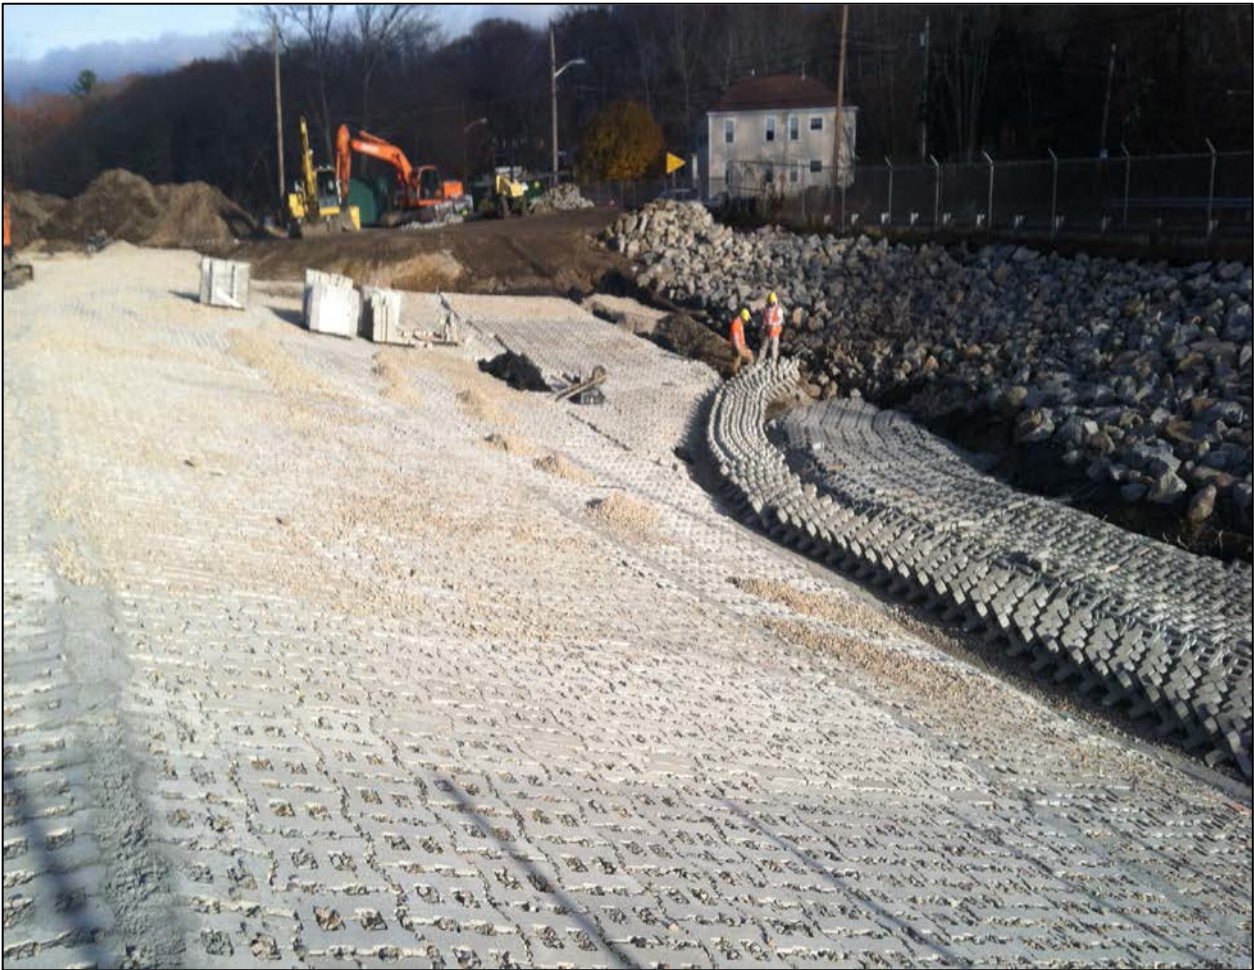
Figure 16. Photograph of ACB System with Armoring Units Installed at the Toe of the System to Provide Energy Dissipation of the Flow

PFM #8 – Vandalism. If the ACB system is exposed, it may be subject to vandalism. Although less susceptible to vandalism than gabions where the wire baskets can be cut or damaged, or riprap, where individual rocks can be rearranged or taken, some features of ACB installations have been prone to vandalism. In particular the end treatment where armoring units (A-Jacks) have been used at the toe of the ACB system to provide energy dissipation (see Figure 16). Figure 17 shows photographs of armoring units that have been damaged by vandalism. It is reported that the damage to the armoring units shown in Figure 17 was the result of kids tossing large rocks against the units. A simple solution to prevent this type of vandalism is to bury the units so that they are not exposed. This may be feasible if the overtopping protection is not frequently activated. If the overtopping protection is frequently activated, covering the armor units with riprap may be sufficient.

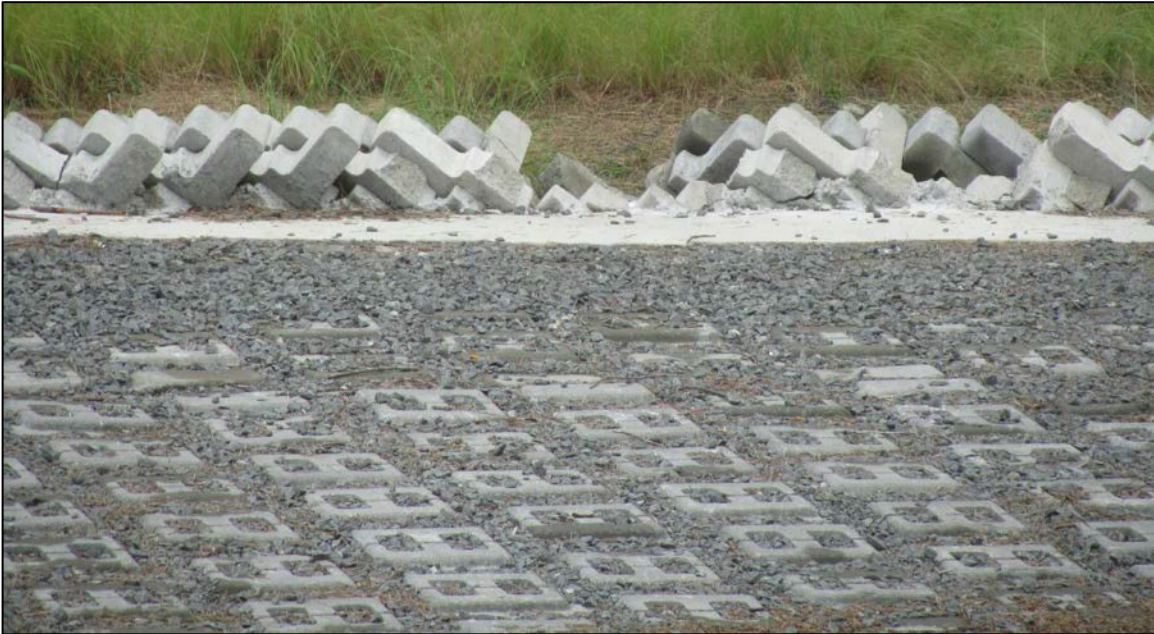
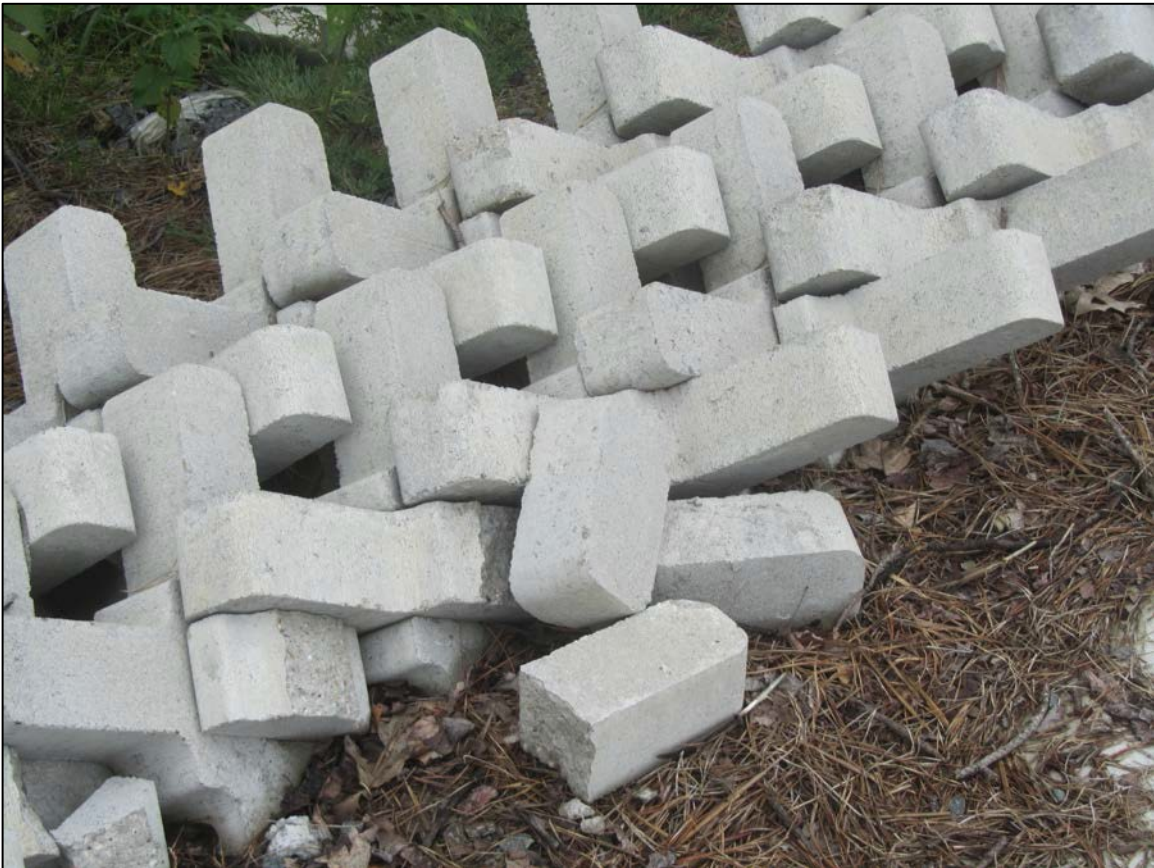
Figure 17. Photographs Showing Armoring Units Damaged from Vandalism

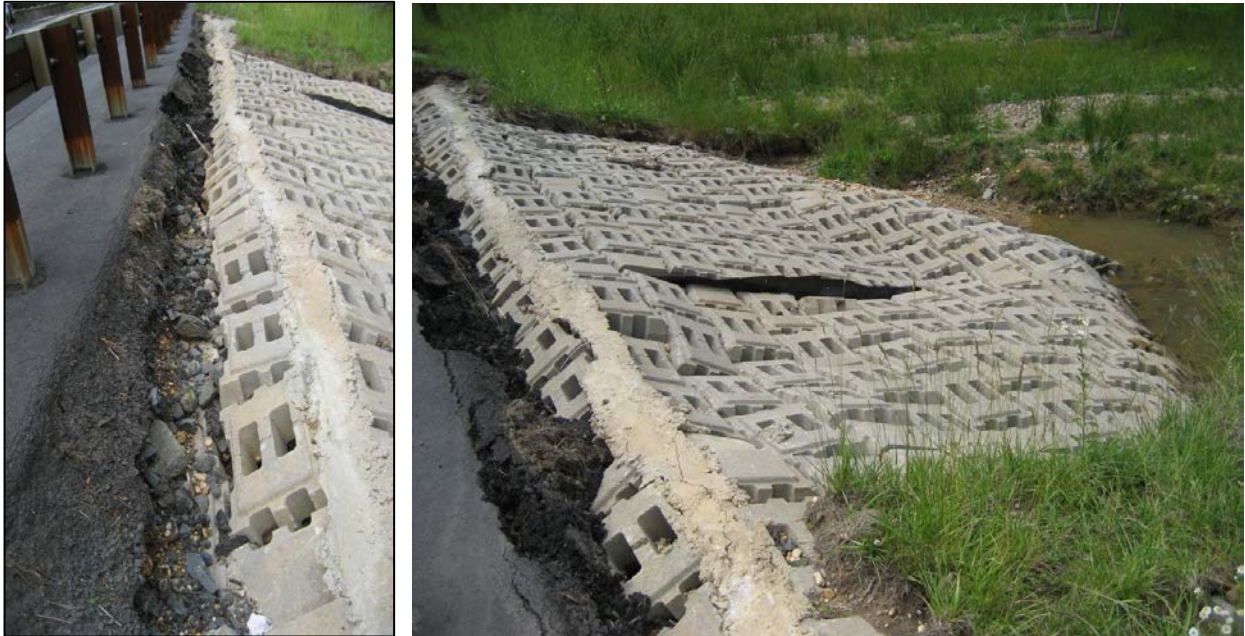
PFM #9 – Poor Transition Details. The upstream and downstream ends as well as the sides, and wherever the ACB system transitions or is connected to another structure, require special attention and details. These transition areas, if not adequately protected can lead to block movement, erosion of the subgrade, and head cutting of the ACB system. Figures 18 and 19 show two examples where problems with the transition details led to movement of the ACB systems, however, there was no uncontrolled release of water.

Figure 18. Photographs of ACB Installation at Grover's Mill Dam Showing Armoring Units Damaged from Inadequate Transition Details at the Top of the Installation

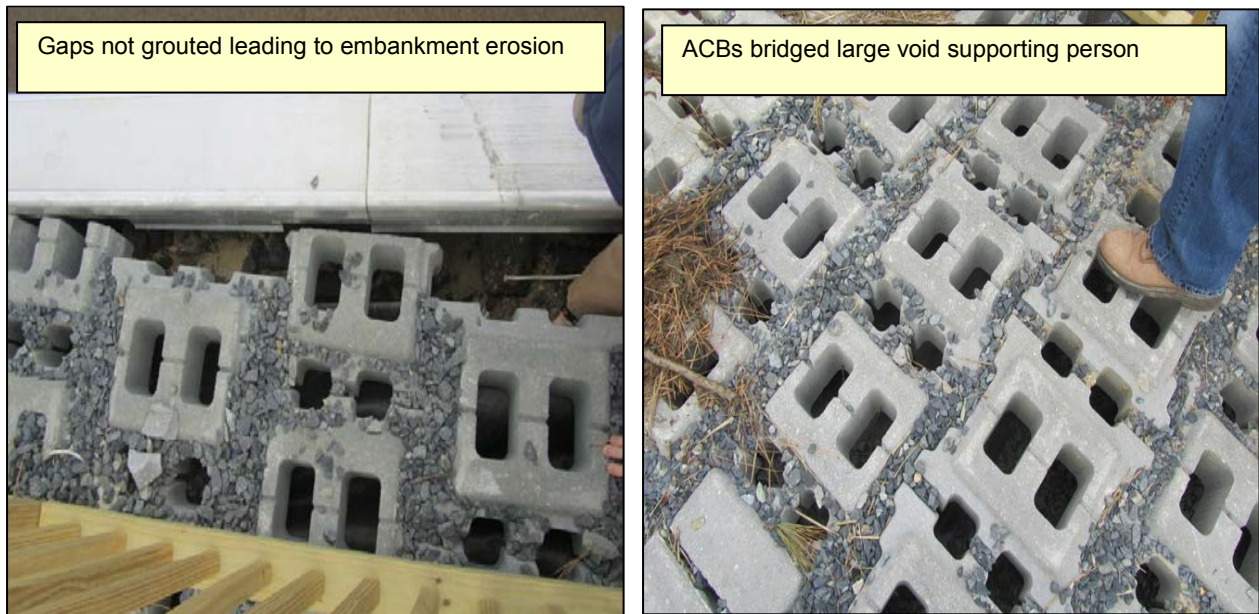
Figure 19. Photographs of ACB Installation at Lake Riviera Dam Showing Inadequate Transition Details along the Right Side of the ACB Installation
